# **Deformation Studies in Warsaw Using Persistent Scatterer** Interferometry based on COSMO-SkyMed and ENVISAT Data

The poster presents selected results of the project "The integrated system of surface deformation monitoring based on Persistent Scatterer Interferometry, measurements from permanent GNSS stations and precise levelling". The main aim of the project is to create integrated system for monitoring ground deformations caused by man-made factors, based on radar satellite interferometry (PSI), permanent GNSS stations and precise levelling.

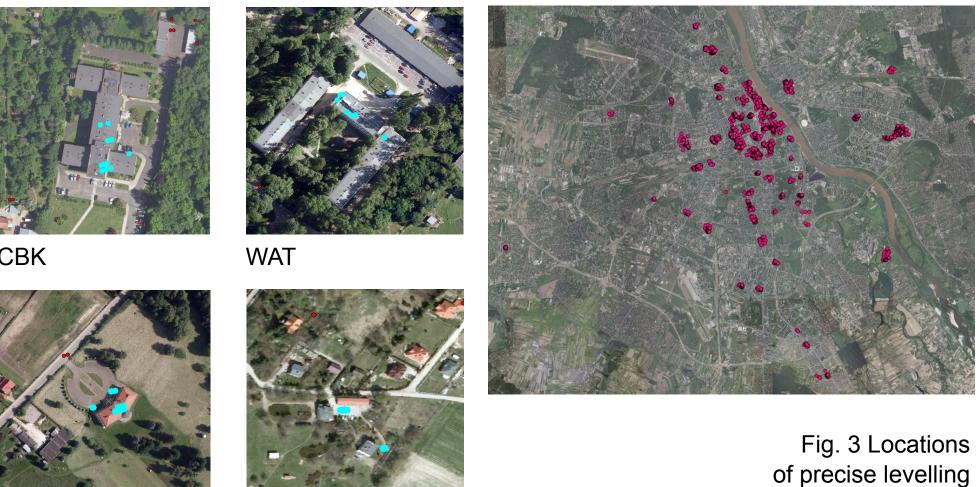
BOGO

measurements from the period 1992 - 2015.

Results of interferometric analyses are validated using measurements from permanent GNSS stations located within the study area and with the use of large archival database of precise levelling measurements and present measurements (including long levelling traverses between permanent GNSS stations). Results gathered from three techniques are analysed jointly, referring to complex geological structure and man-made movements.
